Andy Gibson Wreck (21-AK-109) Fallen Tree Mitigation Report

***Andy Gibson* Wreck (21-AK-109) Fallen Tree Mitigation 2013**

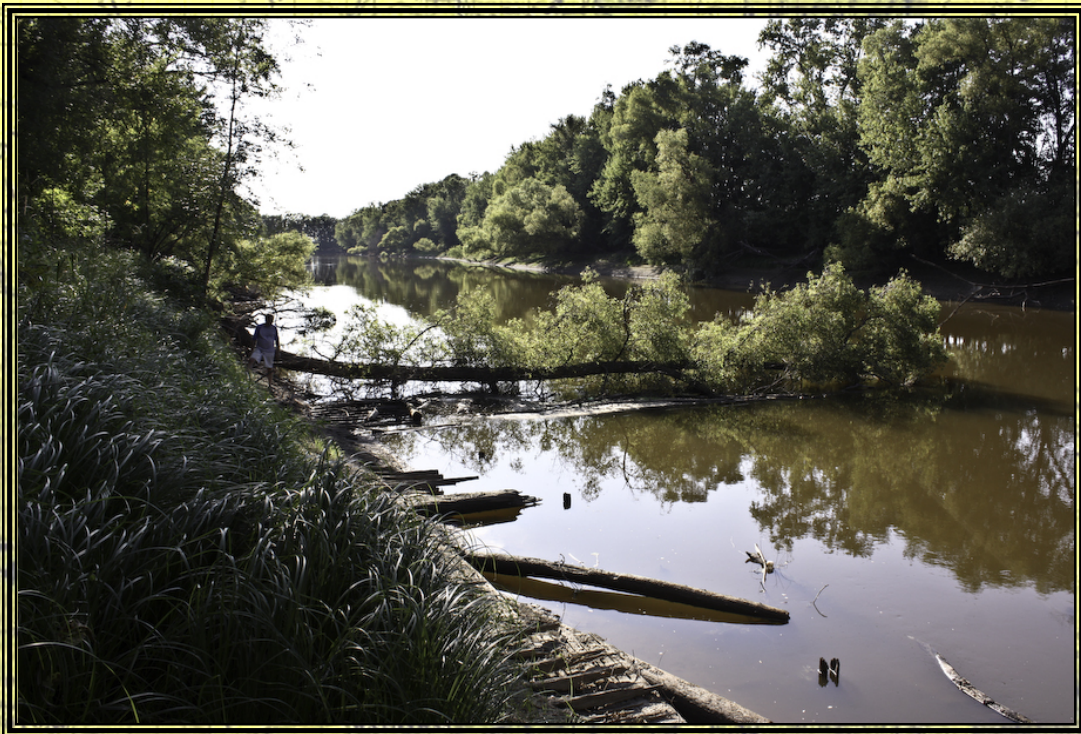
Cover: The fallen tree on the *Andy Gibson* Wreck as discovered on 30 August 2013.

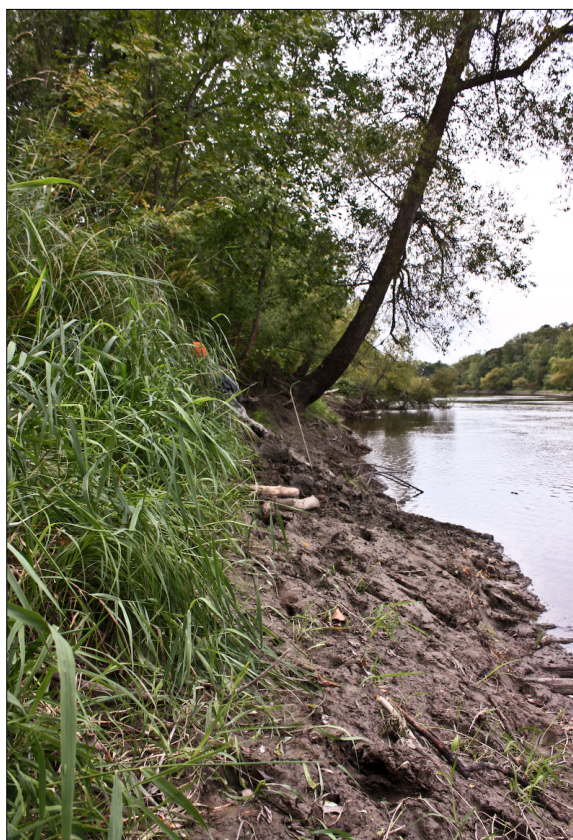
The large tree near the stern of the *Andy Gibson* Wreck site as it looked in mid-September 2011 during medium water conditions (right).

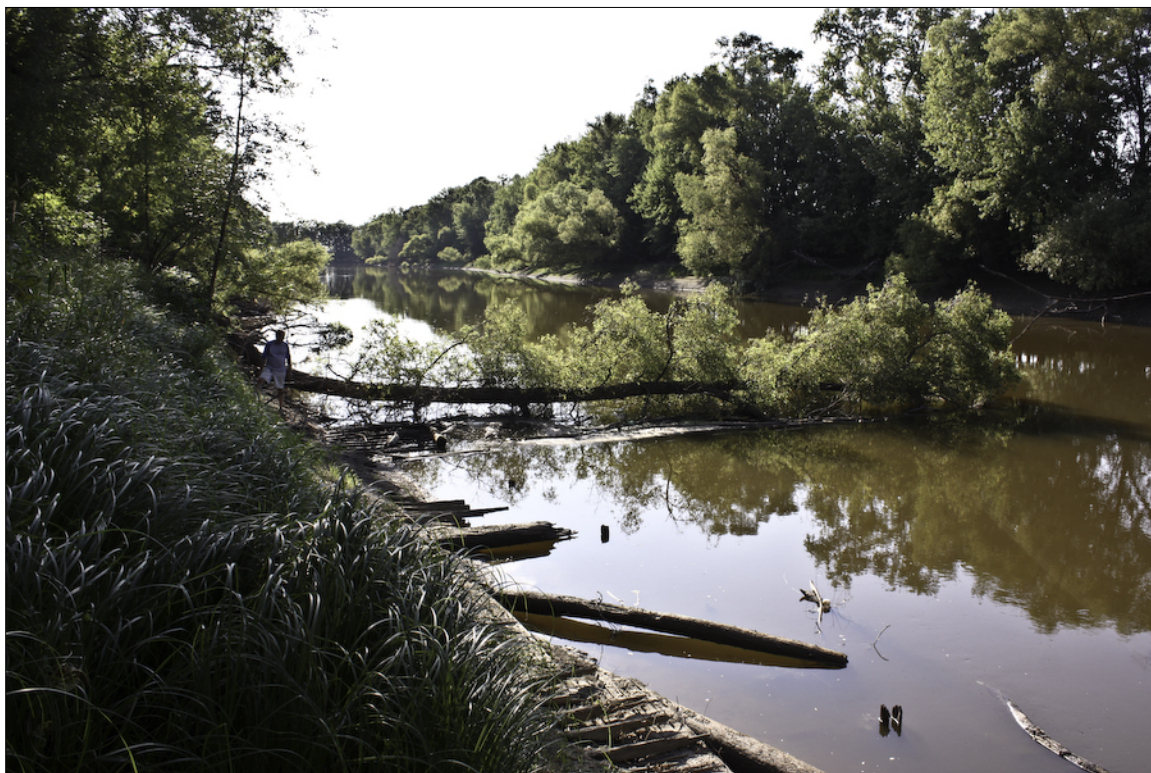
MHM discovered the tree fall on 30 August 2013 during low water conditions.

In 2013, after two floods within a relatively short period time loosened the shoreline matrix at the wreck site, the tree fell into the river and landed on the wreck sometime in the early summer. MHM visited the site for an assessment on 30 August 2013 and discovered the tree fall. The tree created a log jam over the wreck and a significant number of logs and other detritus had already settled on and around the wreck. Aitkin residents Rich and Lorraine Liljenquist visited with MHM at the Mille Lacs Kathio Archaeology Day and discussed the wreck's condition. MHM contacted the City of Aitkin and with the help of the Liljenquists, it was arranged that Bob Nicko, Lon Nicko and Greg Handt of the Aitkin Maintenance Department, Deputy Jon Novotny of the Aitkin County Sheriff's Office, and Adam Stafford and Todd Gretschnann of ASAP Towing, and MHM's Ann Merriman and Christopher Olson would collaborate to raise the tree from the wreck.

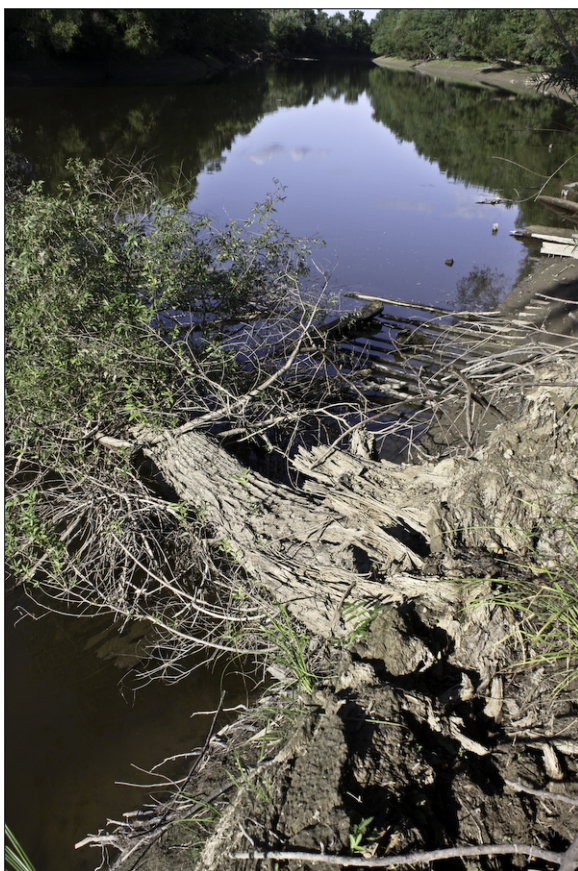
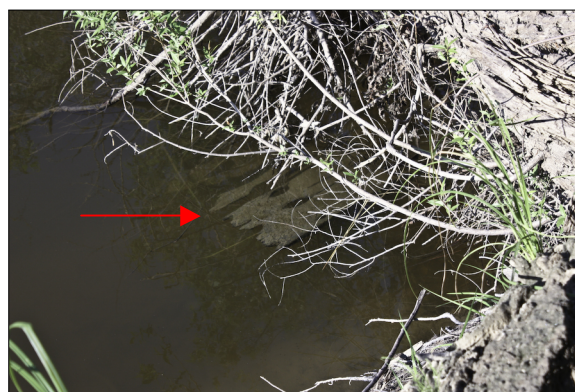
The root ball of the tree remained attached to the root system in the riverbank (left). The wreck's stern outer hull strakes could be seen extending beyond the tree fall as shown by the arrow (above). The photographs were taken on 30 August 2013.

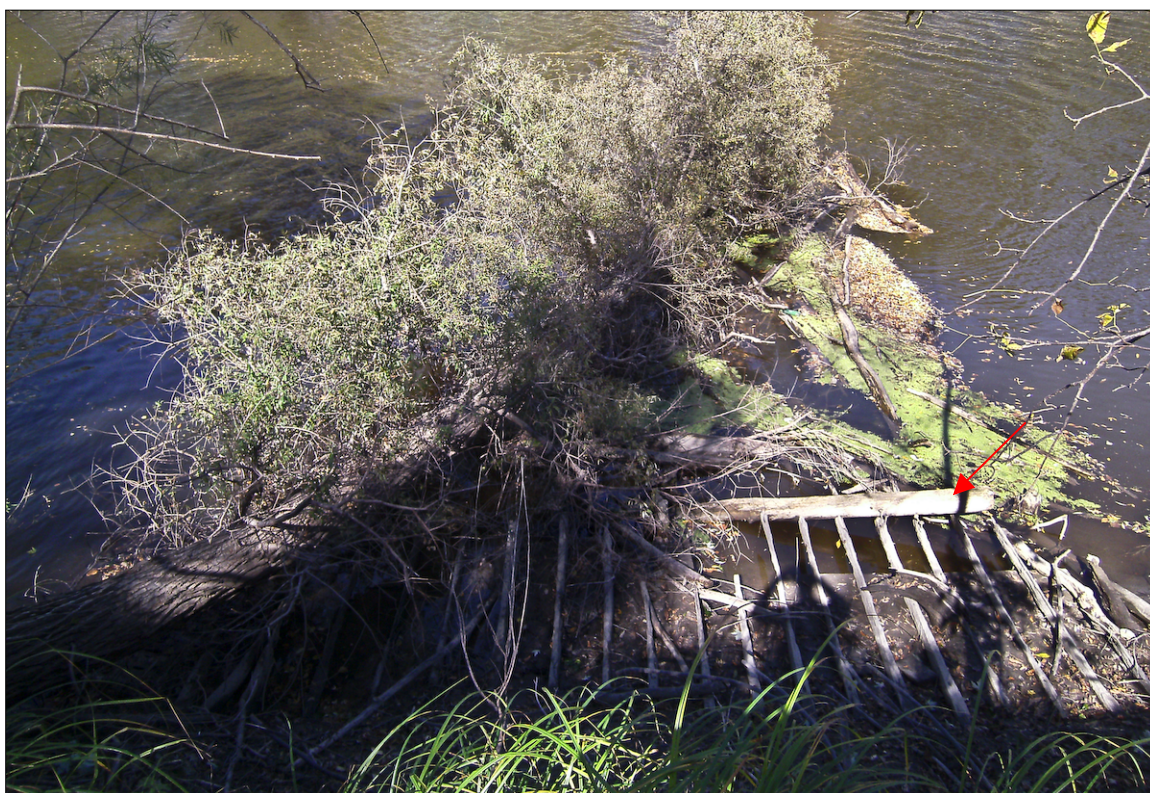
The log jam that the tree fall caused on the *Andy Gibson* Wreck during low water conditions on 1 October 2013. The log indicated by the arrow is not part of the wreck site and was removed by MHM.

On 1 October 2013 MHM staff entered the water at the wreck site and trimmed branches off the fallen tree that might cause damage to the wreck when it was moved. One large branch impacted the site underwater but fortunately no significant damage was done since the limb was curved and did not go through the wreck into the river bottom. Deputy Novotny and Lon Nicko, in the Sheriff's boat, used a chainsaw to cut the tree into manageable pieces that could be safely towed downriver, away from the wreck site. When only the trees root ball and about 10 feet of it remained in the river, Adam Stafford and Todd Gretschnann of ASAP Towing fastened their chains around the tree and the City of Aitkin backhoe pulled it onto the riverbank. Lastly, MHM dislodged a series of large tree trunks and branches that had caught on the wreck over the summer and sent them further downriver or onto the riverbank. Small branches and other detritus had accumulated on the wreck site upriver of the tree and MHM took time and care to clean this debris from the wreck. Upon inspection, a large bottom hull plank at the stern was damaged by the tree fall but remained in place and a section of the bottom hull planking forward of the stern was dislodged by floating trees caught by the 'tree dam'. MHM moved one bottom hull strake back into place as much as possible but another strake could be put back where it belonged because the river current had undercut the silt it was resting on. MHM placed the strake on top of the wreck, securing it for winter; this section of the wreck will be inspected in 2014 for more damage. Toward the bow, only one floor and its associated metal fasteners was damaged by the 'tree dam' and fortunately, that component is already on the *Andy Gibson* site plan. MHM gathered the broken floor as a sample and it is currently under-going the conservation process. With permission from the Office of the State Archaeologist, MHM will present the conserved artifact to the Aitkin County Historical Society in the future.

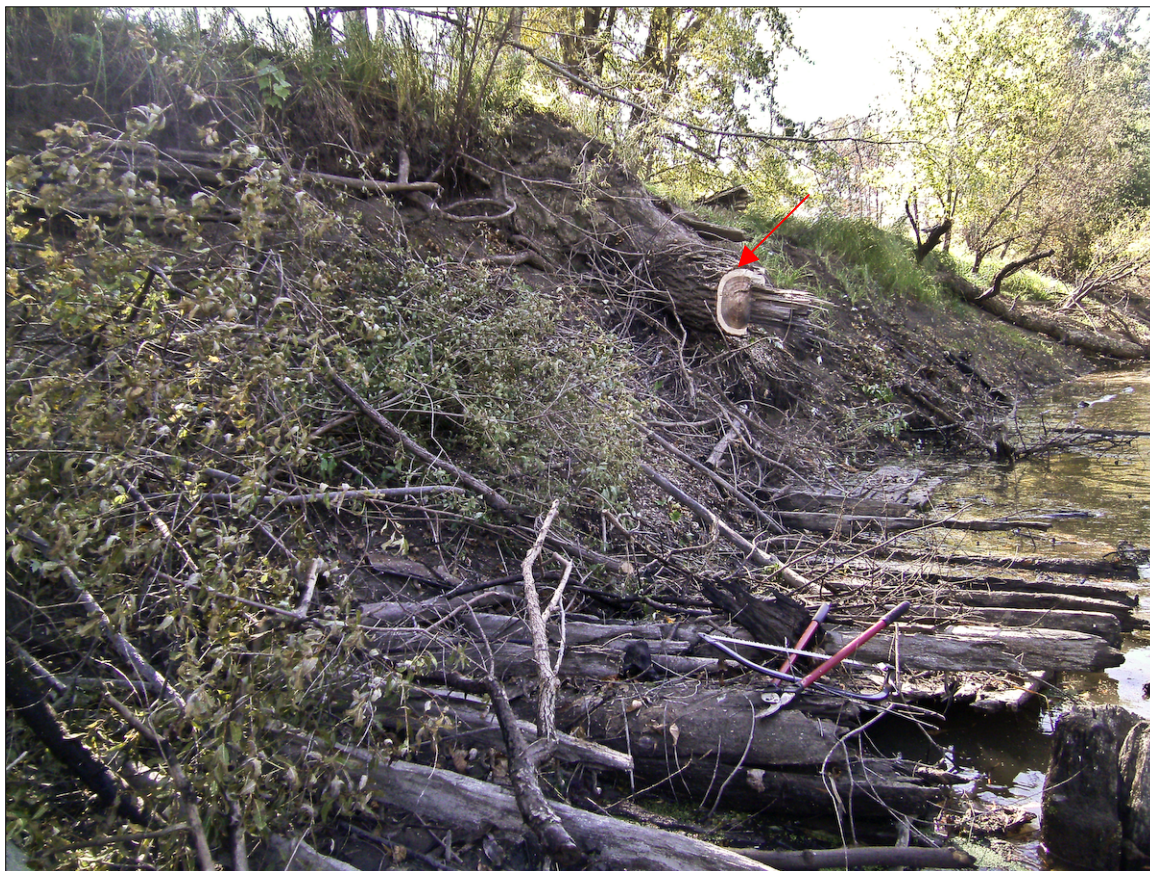
This collection of small branches was trimmed from the fallen tree prior to its raising. MHM moved all the branches up the riverbank and away from the site. The tree stump is indicated by the arrow.

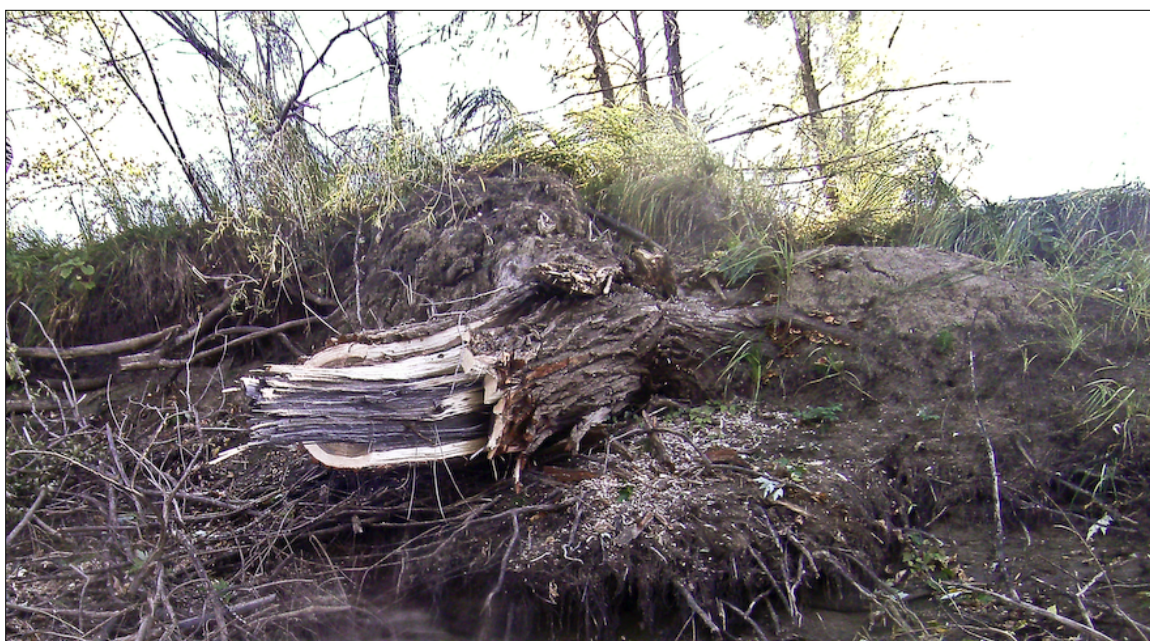
The fallen tree's stump is still in the riverbank. MHM will assess the stability of the stump in 2014 and determine if it requires removal. Part of the starboard stern portion of the *Andy Gibson* Wreck is imbedded in the bank below and to the east of the stump.

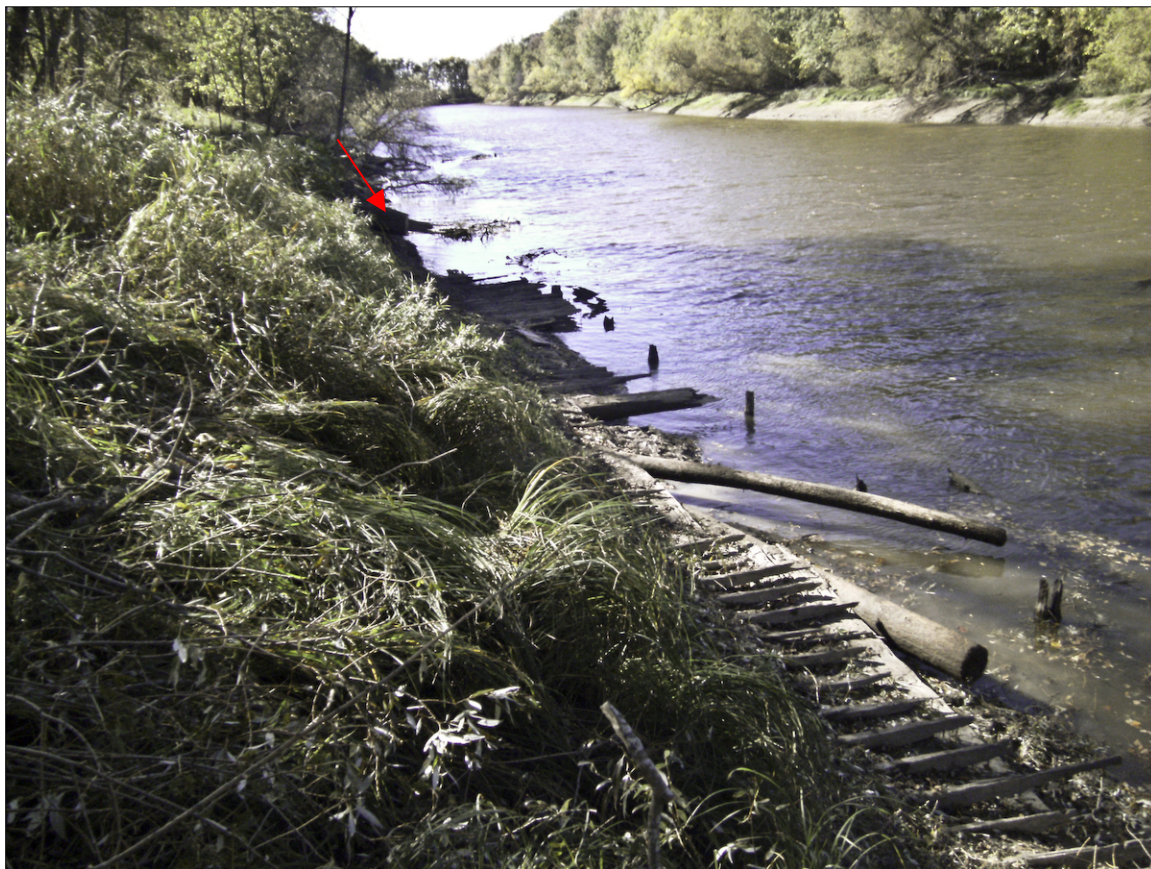
The *Andy Gibson* Wreck site after the removal of the tree looking from the bow toward the stern. The arrow indicates the fallen tree's stump.
